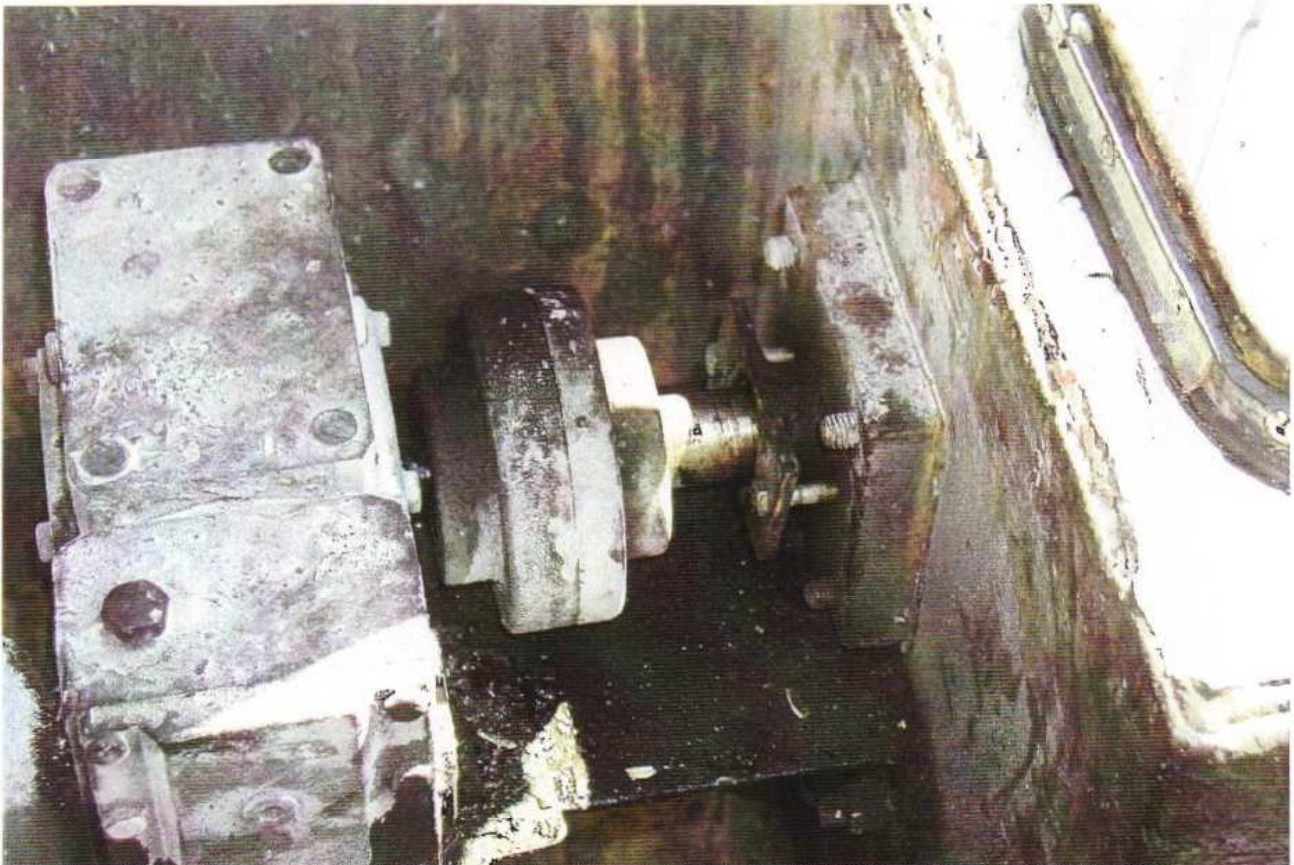
Photograph #7, taken 4/19/2003. The west-side skimmer drive rod, as pictured, was the location of VOC emissions.

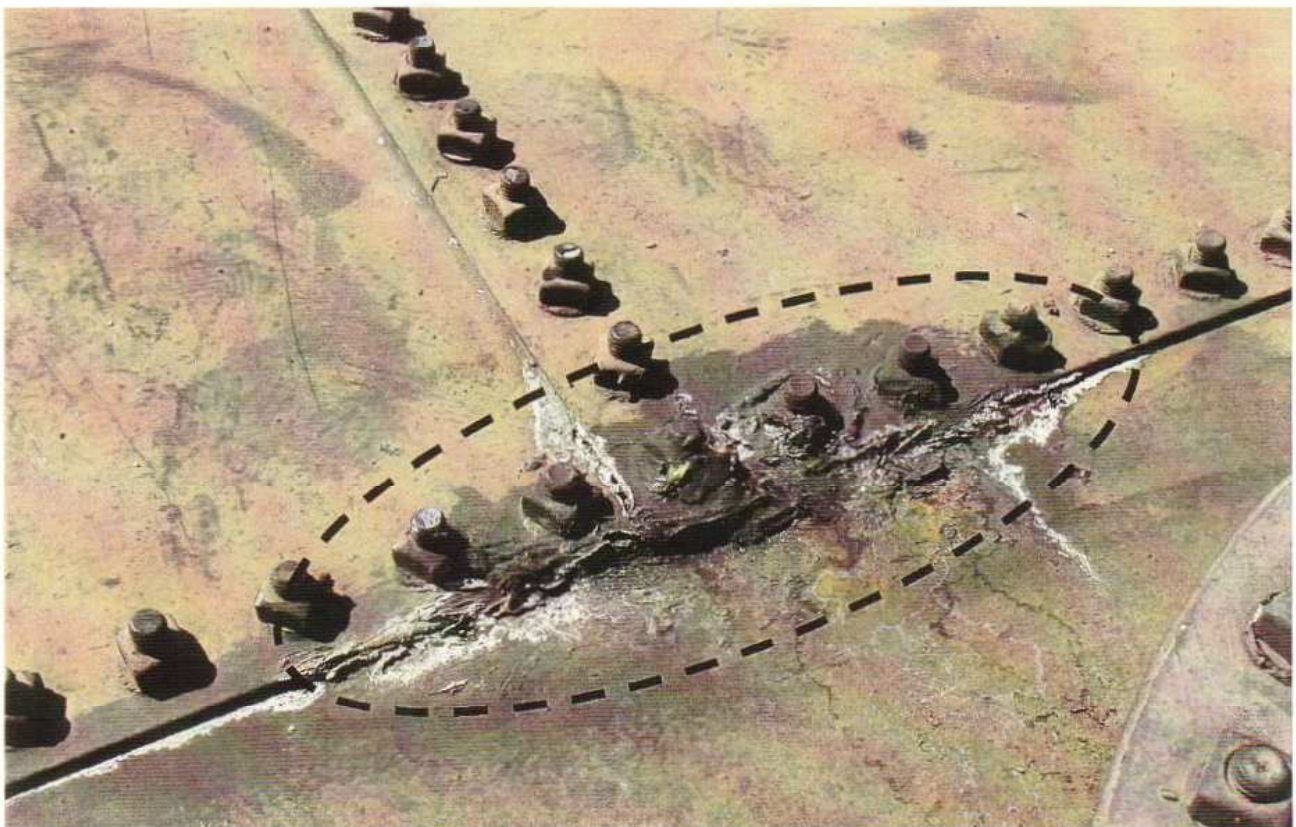
Photograph #8, taken 4/19/2003. Location of vapor leak at the overlap of three bolted plates on the roof of the water injection tank (Item #6, Permit R-D93078, A/N 306537)
