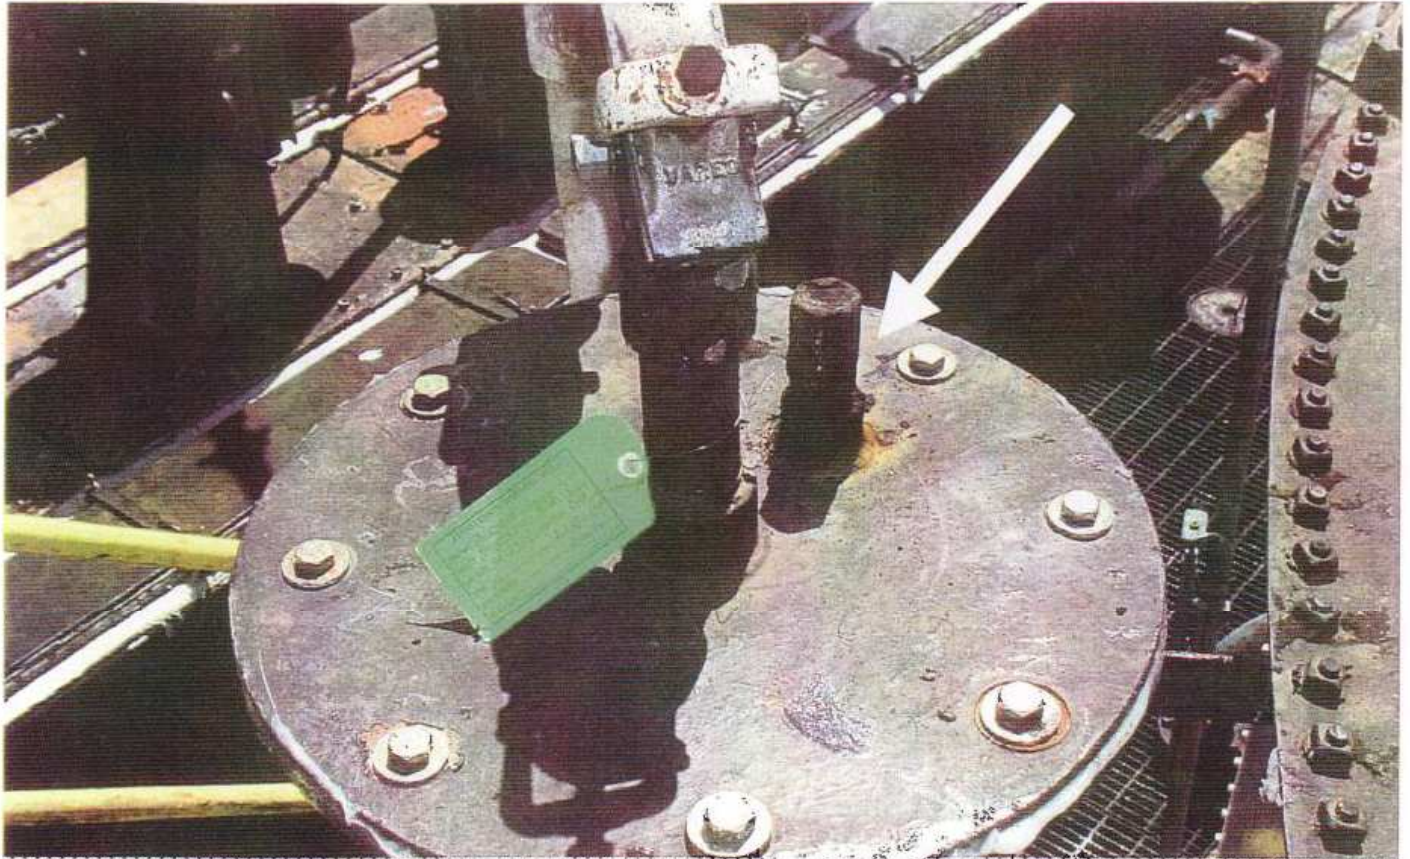
Photograph #9, taken 4/19/2003. The bull plug, as denoted by the arrow, was resting on top of an open threaded connection, allowing VOC emissions from Flange #1412, which is at the top of the external water level boot of the water injection tank.
